SHIRE OF DUMBLEYUNG FOOTPATH STRATEGY

Operations Management Manual

for Footpaths

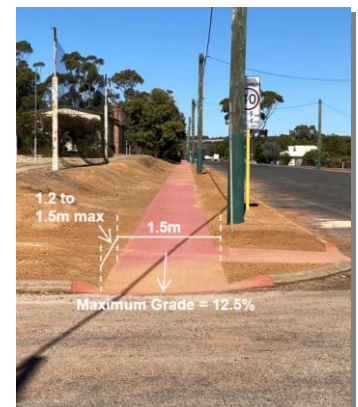
5.3.5 Pedestrian Ramps

There are many varying types of pedestrian ramps within the Shire of Dumbleyung. When footpath renewal works are carried out these will be replaced with ramps that will meet the relevant Australian Standard, currently AS/NZS1428.4.1 – 2021 as shown in the photo to the right. Pedestrian Ramps shall match the width of the path except as required by the needs of the location. A minimum width of 1.5m should be provided at the back of the ramp.

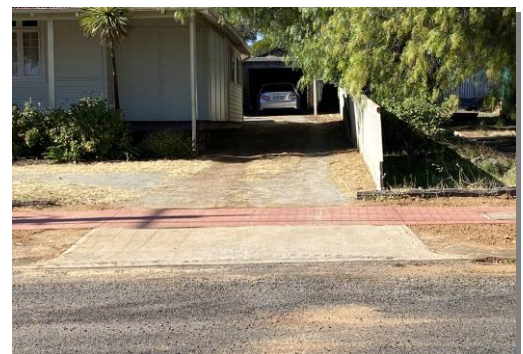
5.3.6 Vehicle Crossings

Where access is required across a path for vehicles then the crossing point shall be reinforced with a single layer of F72 mesh as a minimum. At the discretion of the Shire, a second layer of F72 mesh, and thickening of the footpath may be required at driveways that are frequented by heavy vehicles. The new stamped concrete footpaths will also cut through existing driveways as shown to the right. Property owners can elect to replace the entire driveway with stamped concrete at their own cost.

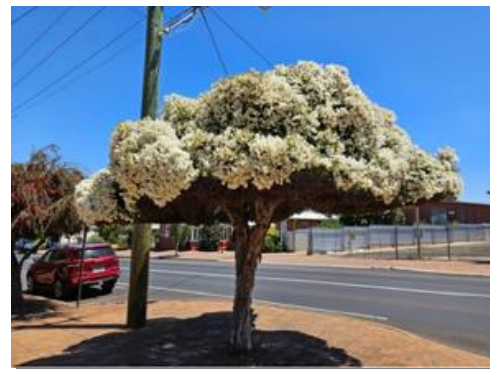
The recommended tree species is *Melaleuca Linariifolia* (photo right) due to this species being evergreen, their upright growth and their leaves remaining consistent throughout the year. Root barriers are also to be installed with each new tree being planted to protect the footpath and other infrastructure from damage. The cost of installing one of these trees every 20m with root barriers has been included in the modelling and program costs.

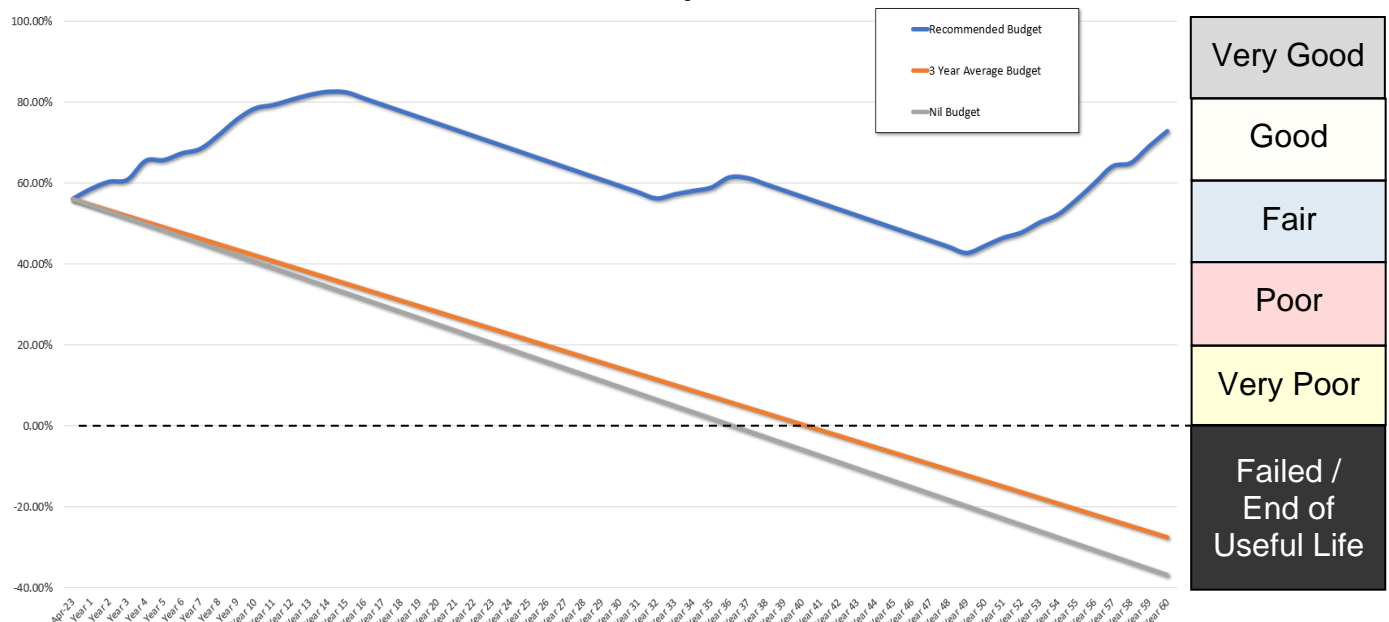
APPENDIX 2 PREDICTED CONDITION

The graph below depicts the strategic modelling results in regard to the condition of the footpath network. The modelling starts from when the condition assessments were carried out (April 23) to the end of the program (year 60 – 2085/86). It also compares the 3 levels of service scenarios, which are:

- The condition of the network if no works were carried out (nil budget),
- The condition of the network if the current expenditure levels are maintained (3 year average budget), and
- The condition of the network if the budget derived from the strategic modelling (recommended budget) was adopted and implemented.

The following can be derived from this graph:

- If no further works were carried out on the footpath network, it would deteriorate into the poor range within 10 years and be at the end of its life within 36 years.

- If the current budget levels were maintained, there would be a declining trend in the condition of the footpath network, which may lead to it falling into the poor range within 11 years and failing or reaching the end of its useful life within 40 years.

- The recommended budget derived from the strategic modelling will see the current condition of the footpath network maintained indefinitely.
- The condition of the footpath network is currently 56% (Fair). As the initial program of works is within the first 15 years, the condition of the network rises up to 83% (very good) over this period. The condition of the network will then gradually decline to 56% (Fair) by year 32 of the program when the 5 year program to replace the remaining brick paved footpaths commences. This 5 year program will lift the overall condition of the network to 61% (Good) before it starts to decline again over the next 12 years until the final renewal works commences at year 50, which will see the overall condition rise to 73% (good) by the end of the 60 year program.

The condition chart provided in Appendix 2 shows that if no works were carried out, the entire footpath network would slip into the "Poor" range within 10 years, "Very Poor" within 23 years and would need to be fully reconstructed in about 36 years. The cost of this in today's dollars would be about \$3,800,000.

The condition portrayed by the graph in Appendix 2 also shows that this level of funding provides a sustainable footpath network that does not place a burden on future generations to bring it back up to an acceptable standard.
